BISHOP'S FALLS

BISHOP'S FALLS FLOOD INFORMATION MAP

Canada - Newfoundland Flood Damage Reduction Program

FLOOD INFORMATION MAP

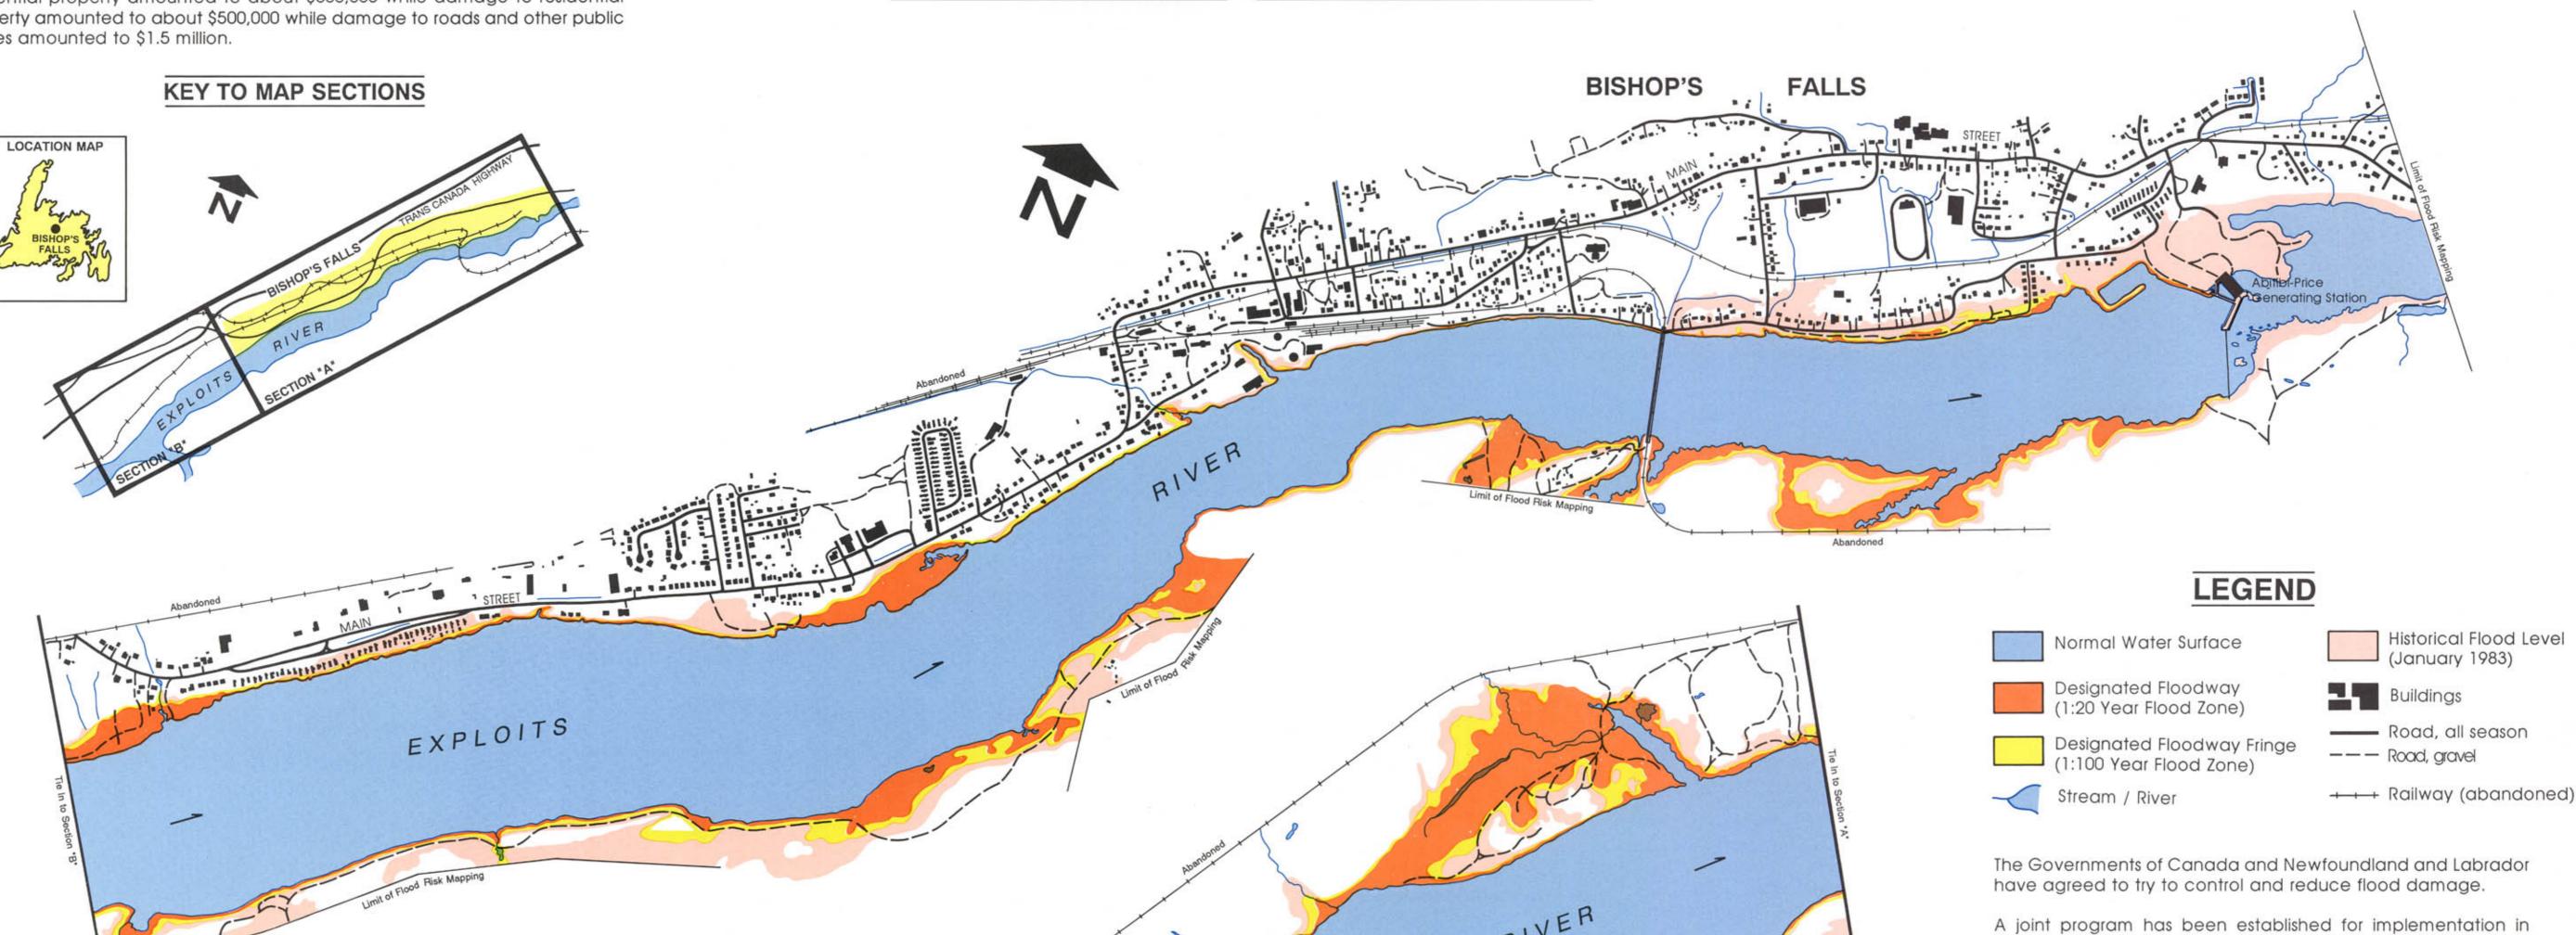
A "designated floodway" (1:20 flood zone) is the area subject to the most frequent flooding.

A "designated floodway fringe" (1:100 year flood zone) constitutes the remainder of the flood risk area. This area generally receives less damage from flooding.

This is a map of the Bishop's Falls flood risk areas - showing the areas prone to flooding - the "designated floodway" in orange and the "designated floodway fringe" in yellow.

The 1:20 and 1:100 flood zones depicted on this map were calculated based on the new Abitibi-Price generating station which was constructed in 1984.
